Golf Course Water Quality Study at Cannon Air Force Base New Mexico

Air Force Center for Environmental Excellence
3300 Sidney Brooks
Brooks AFB
San Antonio, Texas 78235

April 2004

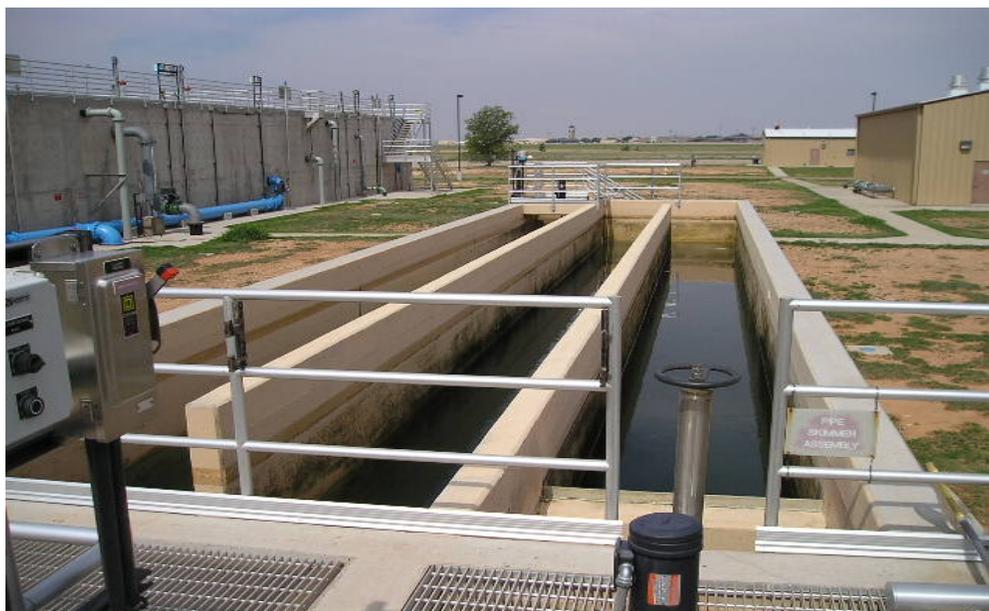
Wastewater Treatment Plant components—chlorine content basin (foreground) and sequencing batch reactors (left)

Both domestic and industrial wastewater produced by the installation is collected and treated at the base's Wastewater Treatment Plant (WWTP) (Figure 3). The WWTP uses a Sequencing Batch Reactor (SBR) process technology and began operations in June 1998. Effluent from the SBR process is disinfected with sodium hypochlorite in the chlorine retention basin. The initial chlorine target dosage is typically 1.5 to 2.0 mg/l, with a target chlorine residual at the over flow weir of 0.5 mg/l.

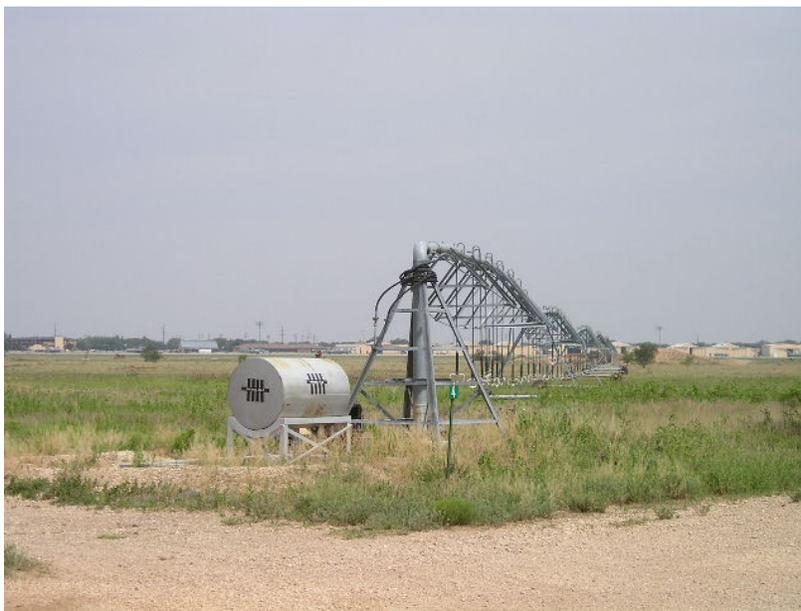
Spray Irrigator for Playa Lake

charge point from the lake; all water is infiltrated or evaporated from its approximate 18.3-acre surface. A spray irrigation pumping station can draw from Playa Lake whenever the lake is too full. Unfortunately, this system experiences clogging problems similar to WWGC, which reduce its effectiveness.

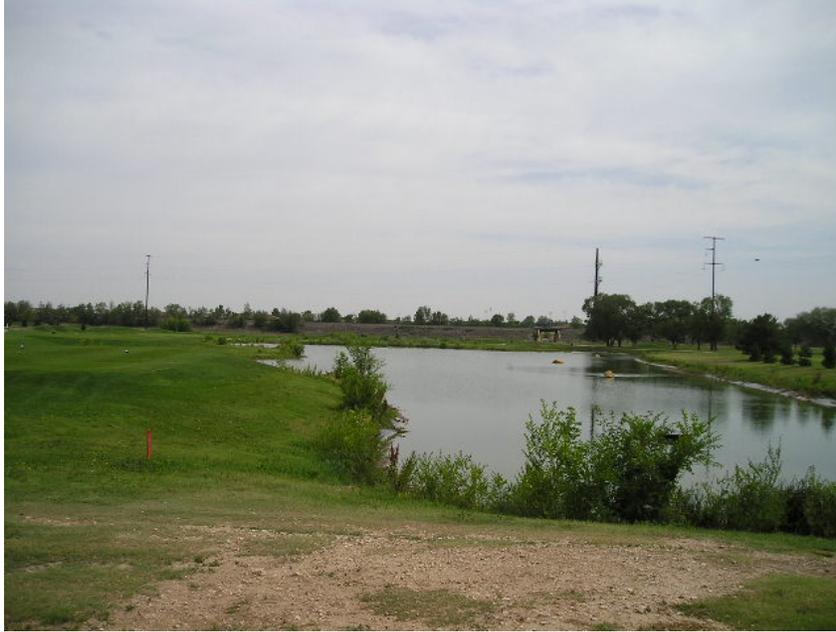
Golf Course Main Pond

The WWGC main pond is located approximately 7,200 feet from the WWTP and covers approximately 4.15 acres (Figure 4). It has a relatively flat bottom approximately seven feet deep covered by a relatively thin synthetic liner. Based on its area and depth, the total volume of the pond is estimated to be approximately nine million gallons. Pond water levels are maintained by flow from the WWTP and nearby well water, which can be routed through the common line to feed the pond. This line enters the pond on its east side through a submerged discharge pipe approximately six feet from the pond's edge. These flows are augmented by limited, occasional stormflows. Although the WWTP flows now constitute the primary source of water, golf course operators have had to temporarily dilute these flows with groundwater from the nearby well to combat bio-fouling. Two floating aerators have been added to the pond and are reportedly to have reduced algae growth.

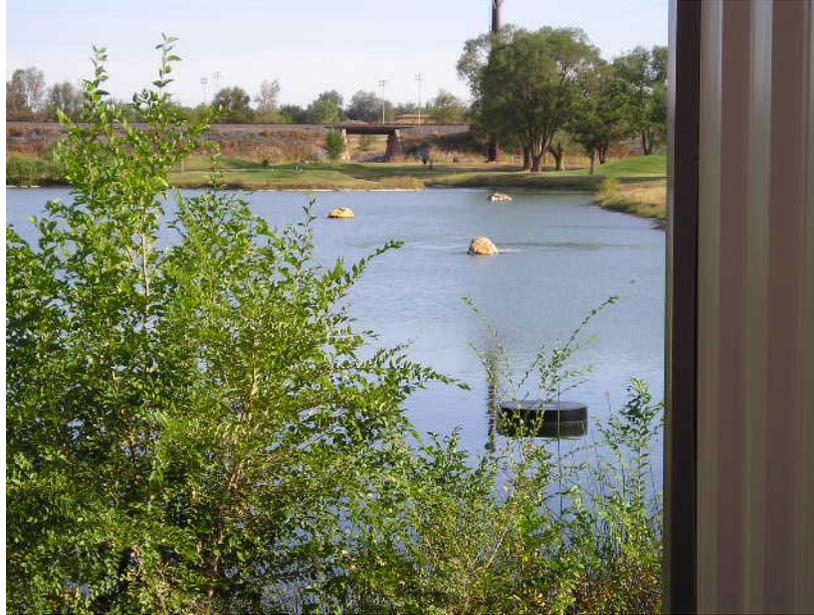
Golf Course Main Pond with floating intake (foreground) and floating aerators as fake rocks

Water from the Main Pond is collected through a floating intake pipe into a wetwell and pumped by a “package” lift station manufactured by Pumping Systems Inc. (Model 10M50) to the irrigation distribution piping system. The irrigation duplex pump motors are 50 HP, 480 VAC, 3 phase and the six stage pumps are capable of delivering approximately 600 gpm individually and 1,100 gpm collectively. During a typical day in the primary irrigation season (April through September), 500,000 to 800,000 gallons of water may be pumped from the Main Pond for irrigation use. The system is used and maintained year-round, although the volume irrigated is significantly reduced between October and March.

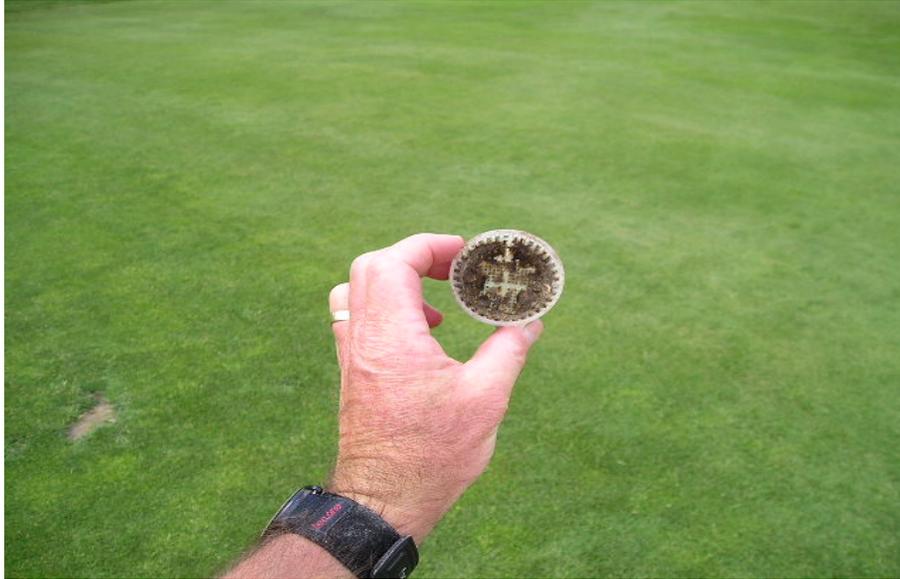
Sprinkler screen with dried bio-fouling materials, including macro invertebrate particulates

Observations of color and physical character were made during field sampling. Water samples from the Main Pond and Playa contained numerous skeletal remains of macroinvertebrates. Significantly, the same fragments were found in each slime sample taken and in every clogged sprinkler head examined. The particles observed were generally 3 to 20+ millimeters long. They have only a slightly greater specific gravity than water and are readily suspended with minor water turbulence.

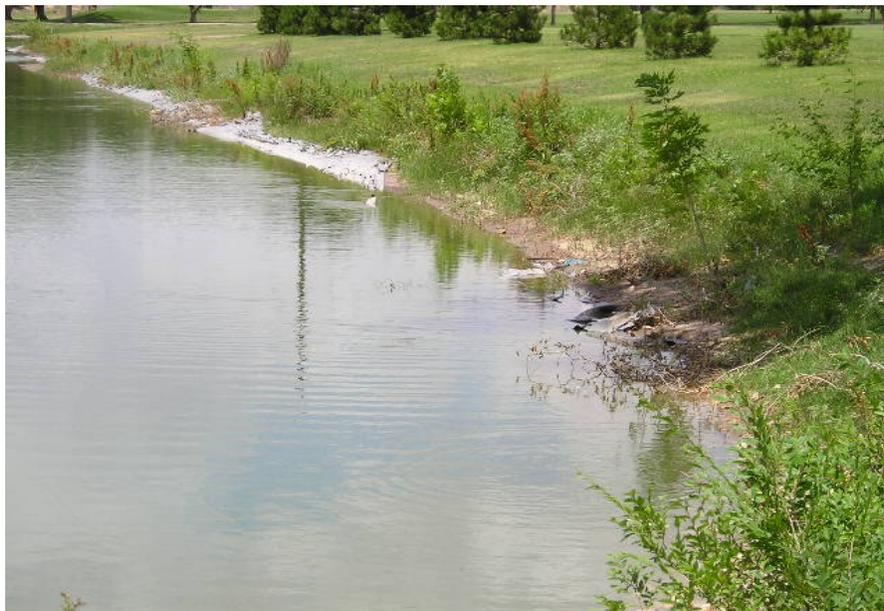
The liner at the Main Pond is not totally effective

During the Main Pond inspections and soundings, the condition of the liner for the pond was found to be poor. There are gaps in seaming and some apparent holes. Although the volume of loss was not quantifiable (irrigation metering had not yet been installed), the relatively sandy soils on site could transmit significant water from the pond. This loss could increase the volume of WWTP effluent required to maintain the pond level.

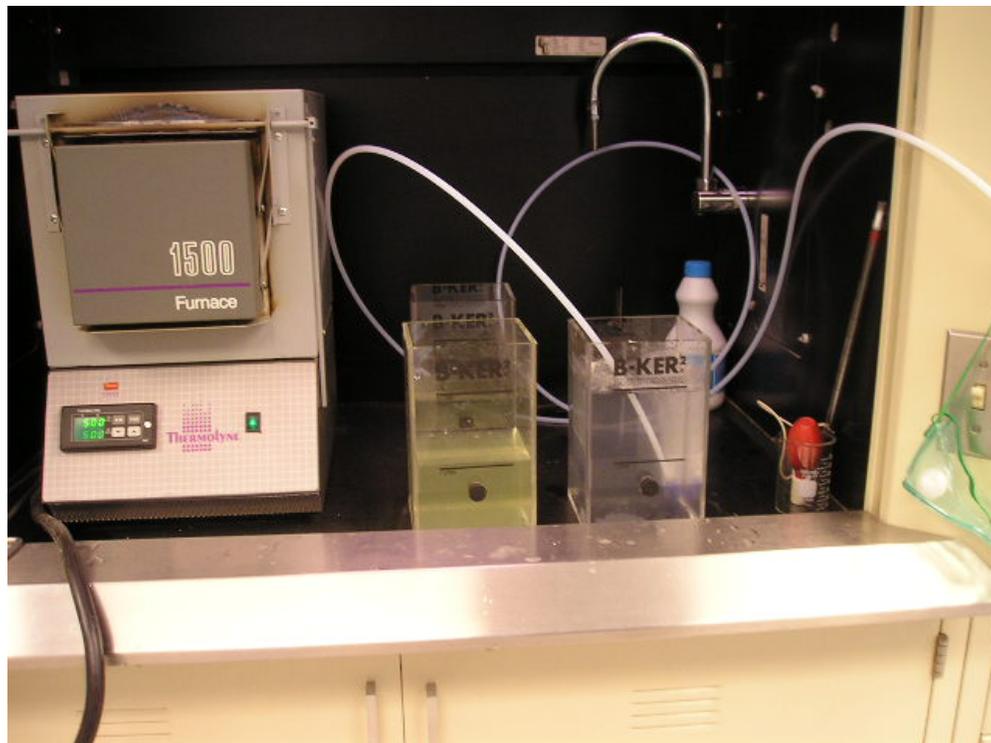
Irrigation system influent before and after ozonation

Ozone appeared to kill the water's microorganisms such as flagellates, bleached the algae's chlorophyll, and significantly improved the water's turbidity.

The SLYM's cloudy yellow color indicates the presence of SFB. The appearance of cloudy water within 60-hours indicates the SFB population was significantly reduced to less than 2,000 cfu/ml.
